**An Architectural Study of Some Folk Structures in the Area of the  
Paintsville Lake Dam, Johnson and Morgan Counties, Kentucky**

4. TITLE (and Subtitle) <b>An Architectural Study of Some Folk Structures In the Area of the Paintsville Lake Dam Johnson and Morgan Counties, Kentucky</b>		5. TYPE OF REPORT & PERIOD COVERED

7. AUTHOR(s)  <b>Ronald C. Carlisle</b>		6. PERFORMING ORG. REPORT NUMBER
9. PERFORMING ORGANIZATION NAME AND ADDRESS <b>Department of Anthropology University of Pittsburgh Pittsburgh, PA 15260</b>		8. CONTRACT OR GRANT NUMBER(s)  <b>DACW69-77-C-0132</b>

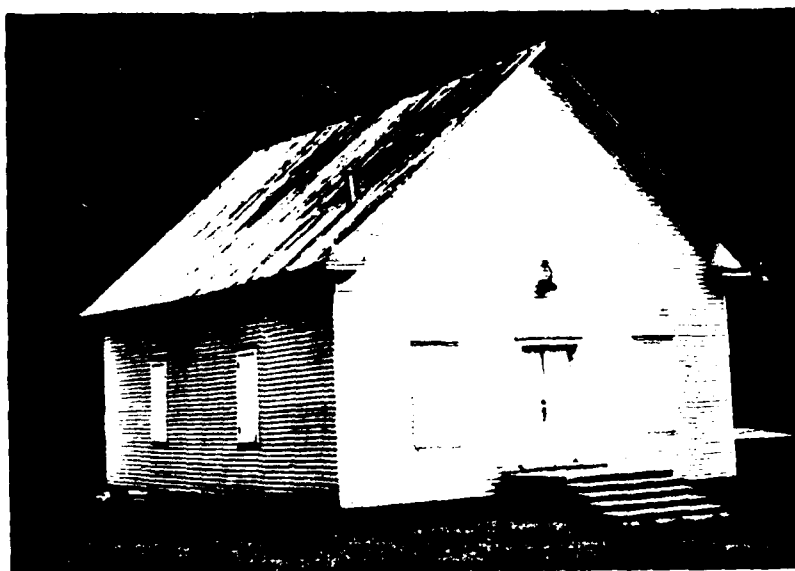
Figure 14. The Fishtrap United Baptist Church following its relocation by the U.S. Army Corps of Engineers. The structure was moved to a location approximately 800' southwest of its original site on Paint Creek. Despite the efforts of the Corps of Engineers to relocate the structure in a viable setting, the congregation has constructed a new brick church. The original structure is no longer used for weekly services.

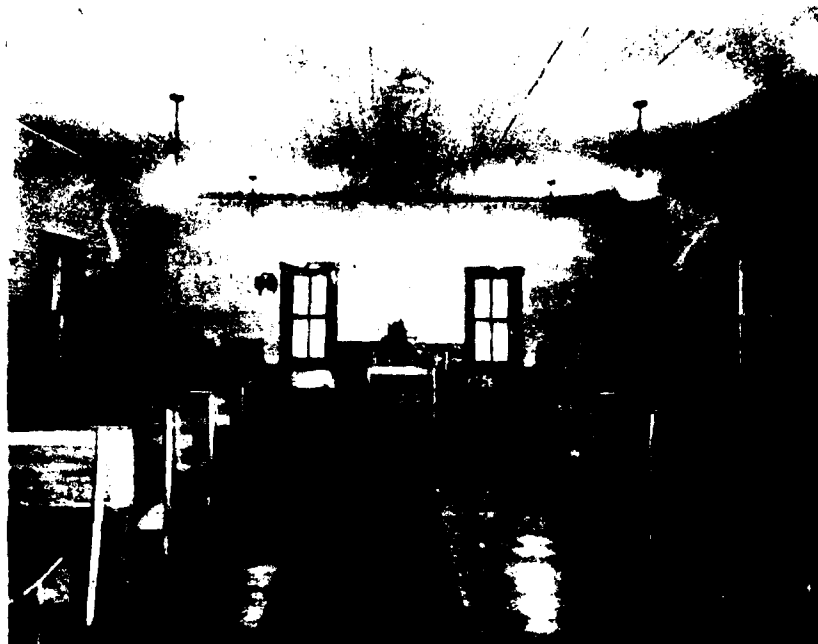
Figure 15. Interior view of sanctuary of the Fishtrap United Baptist Church looking toward the altar area. Note pews, windows and globular electric lights. Prior to the extension of electric service to the area, suspended kerosene lamps were employed (George Van Hoose 1978, pers. comm.).

Entrance through the church's single doorway in the northwest wall leads directly to the sanctuary and the central aisle. At the opposite or southeastern end of the room is a simple wooden altar area (Figures 15, 16) that is raised 7" above the floor. The length of the altar area runs across the width of the room and is itself 7'11" in width. It accommodates two sets of three wooden pews that face each other and are separated by the low wooden pulpit. A solitary pew is placed behind the pulpit. There are a total of nine rows of bench-type straight back wooden pews provided for the congregation on either side of the central aisle (Figure 15). Each congregational pew is 9'11" in length, 1'10" wide and ca. 3' in height. They are spaced at ca. 1'4" intervals. Pews on the altar platform are similar in construction but are 7'10" in length. Pew construction consistently employs milled lumber, but the type of nails used is not available.

Near the altar area (see Figures 15, 17) is a metal floor grate used with the gas heating system.

Currently, light is supplied by two rows of three globular electric lights suspended from the ceiling by lengths of chain (see Figures 15, 17). These are controlled from a switchbox at the top left of Window E (see Figure 15). As noted above, prior to the use of electric lights, suspended kerosene globe lights, possibly in the same positions as those now used, were employed (George Van Hoose 1978, pers. comm.).

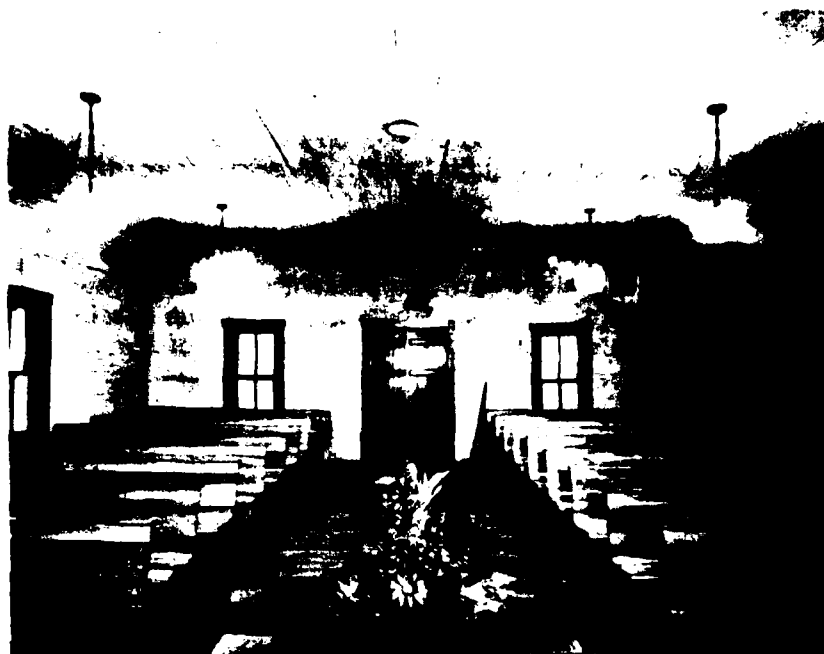
Figure 17. Sanctuary of the Fishtrap United Baptist Church looking toward the structure's solitary door from the altar area.

As noted above, the present heating system for the church is a gas-fired suspended furnace located in the north corner of the building (see Figure 17). The previous heating

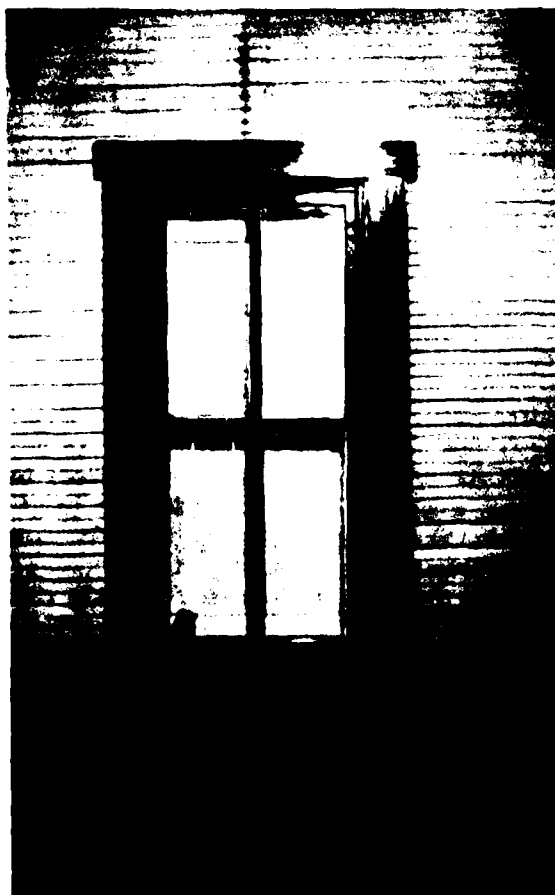
Figure 18. The Fishtrap United Baptist Church, close-up of two over two light double hung sash window. Note absence of window hardware.

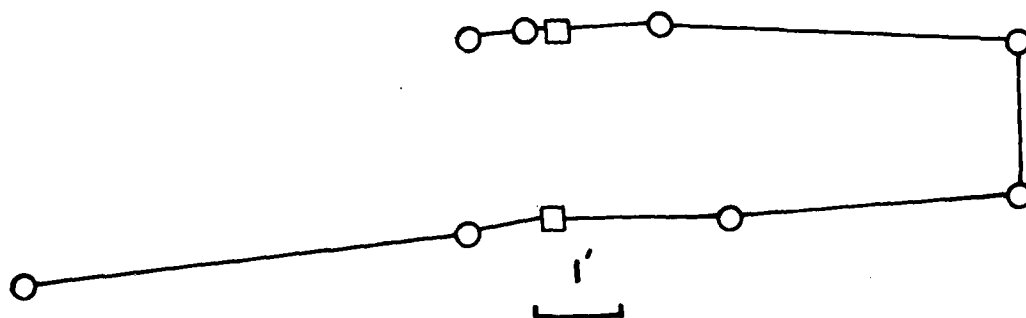
Figure 19. Plan of Tract 307 mule breeding stanchion. The original drawing was provided by Dr. Robert F. Maslowski and Ms. Lynn Lady, U.S. Army Corps of Engineers, Huntington District, West Virginia. (Compass orientation not obtained).

Compass orientation of the stanchion was not recorded when the floor plan sketch which formed the basis for Figure 19 was made. From Figure 20, however, it is clear that one preserved side of the stanchion is longer than the other. Maximum length along this side measures 6'10". It is not known whether the "shorter" side may once have been coequal in length with the "longer" side, though this seems a distinct possibility. The stanchion is slightly narrower in interior dimensions across the back than at its mouth and measures 1'9" and 2'11" at these points, respectively.

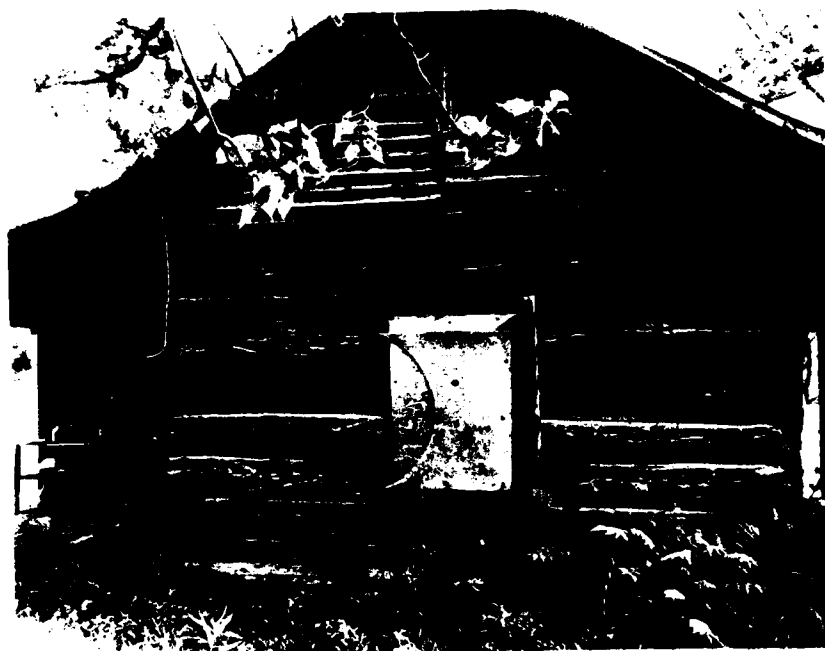
Figure 36. Western elevation of the western pen of the McKenzie dwelling. Note porch on southern elevation at right and the small, offset porch at left. Note also the heavily weathered mud chinking between the logs and the horizontally applied circular sawed weatherboarded gable.

The western pen of the structure (Figures 29, 34-40) is composed of logs of yellow pine (*Pinus* sp.). These, too, have been dressed with a broadax on their interior and exterior surfaces and retain their natural convexity on the decorticated superior and inferior faces. There are 10 logs in the northern and southern elevations with nine logs in the eastern and western elevations (Figure 36). The latter rest on a (now) collapsed sandstone wall foundation. The additional log in each wall of the western pen over and above the number found in the eastern pen was necessitated by the generally smaller size of the logs employed in the former. These range from 10" to 1' in height and are ca. 6" in thickness. Half dovetail notching is the predominant corner notching technique employed, but this is not exclusively so; as can be seen in Figure 34, both inverted V and square notching also are used. The 2"-5" interstices between the logs of the western pen also show evidence of mud chinking much of which either had washed out or had crumbled away at the time that the survey was conducted. This second pen is somewhat smaller in overall dimensions than the eastern pen and measures 14'4" across its south wall and 16'4" across its western wall.

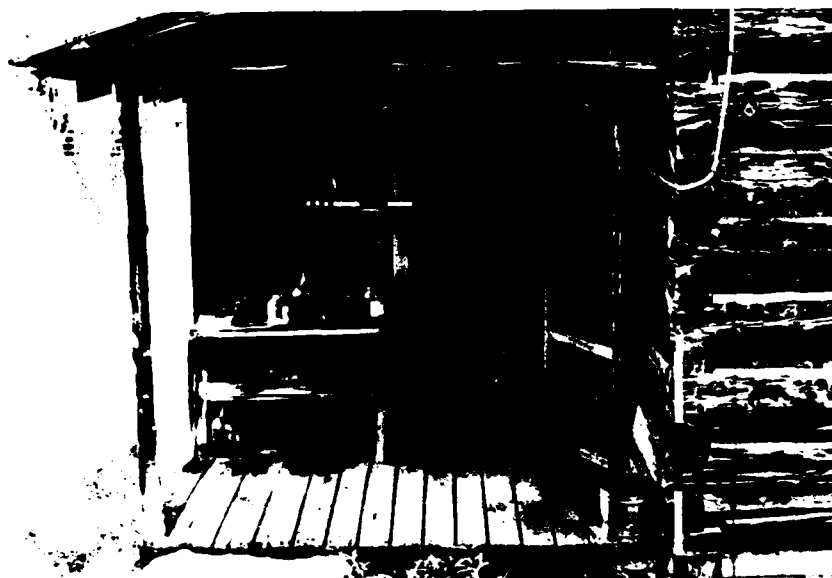
Figure 38. Close-up of offset porch at the northwest corner of the McKenzie dwelling. Note the board and batten construction of the addition to the log portion of the home.

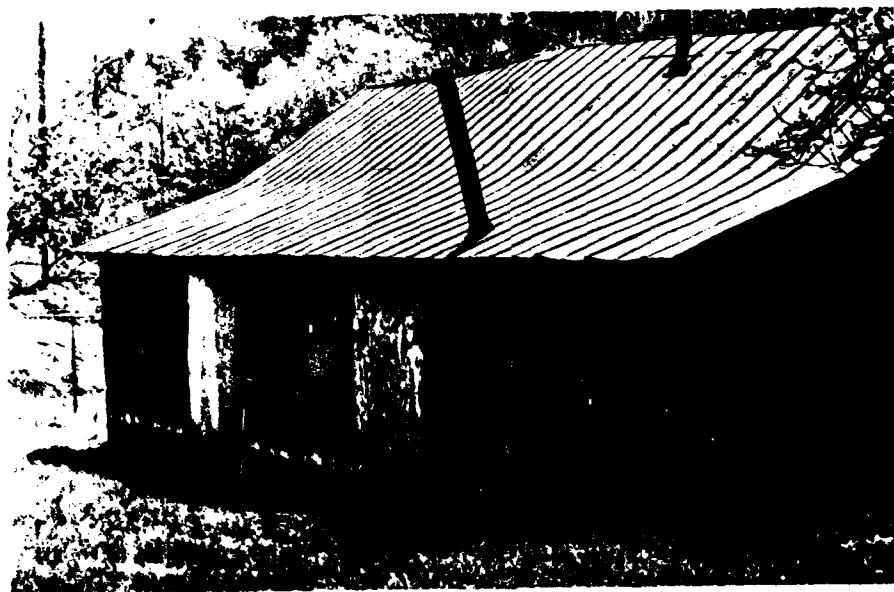
Figure 40. Northern elevation of the McKenzie dwelling showing the board and batten construction of the addition to the log portion of the home. Note rolled metal roofing.

Attached to the north or rear elevation of the two log pens is a 29'4" x 7'7" board and batten construction addition as well as a 7'7" x 5'9" open-walled but roofed porch (see Figures 38-40). Porch flooring (see Figure 38) here consists of a simple arrangement of 15 planks each ca. 6" in width. Everett McKenzie recalled that the present frame addition was constructed ca. 40-45 years ago (ca. 1935-1940) by his brother-in-law, Norman Williams, when Everett's parents, Forest and Lou McKenzie lived in the structure. This addition replaced an earlier log addition that according to Mr. McKenzie adjoined only the eastern pen of the dwelling (McKenzie-Carlisle Interview August 6, 1980). The logs on the north side of the eastern pen, however, are much more weathered than are those on the western pen as though they were exposed to the elements for a considerable amount of time. At present, therefore, it is impossible to specify the composition and configuration of the original addition to the north side of the extant structure.

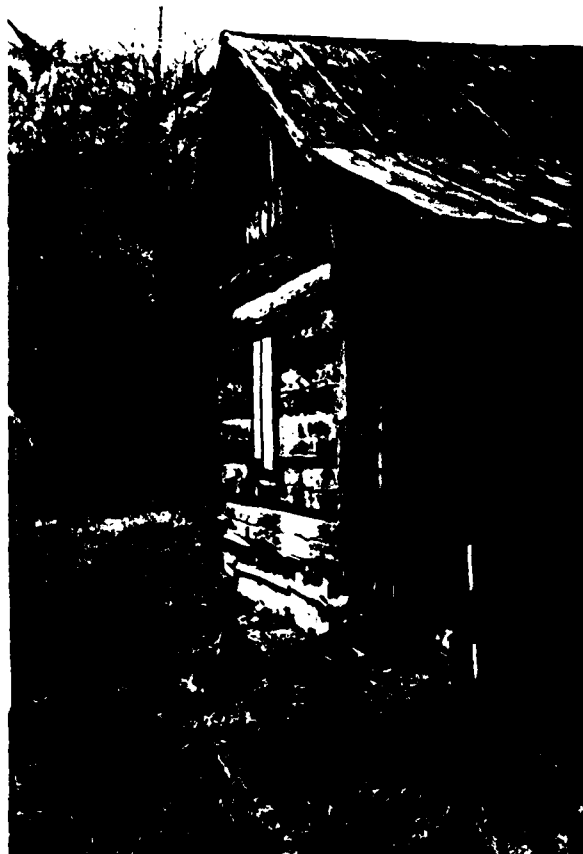
Figure 42. Northeast corner of the McKenzie dwelling. Note sandstone pier support for the frame addition in the foreground.

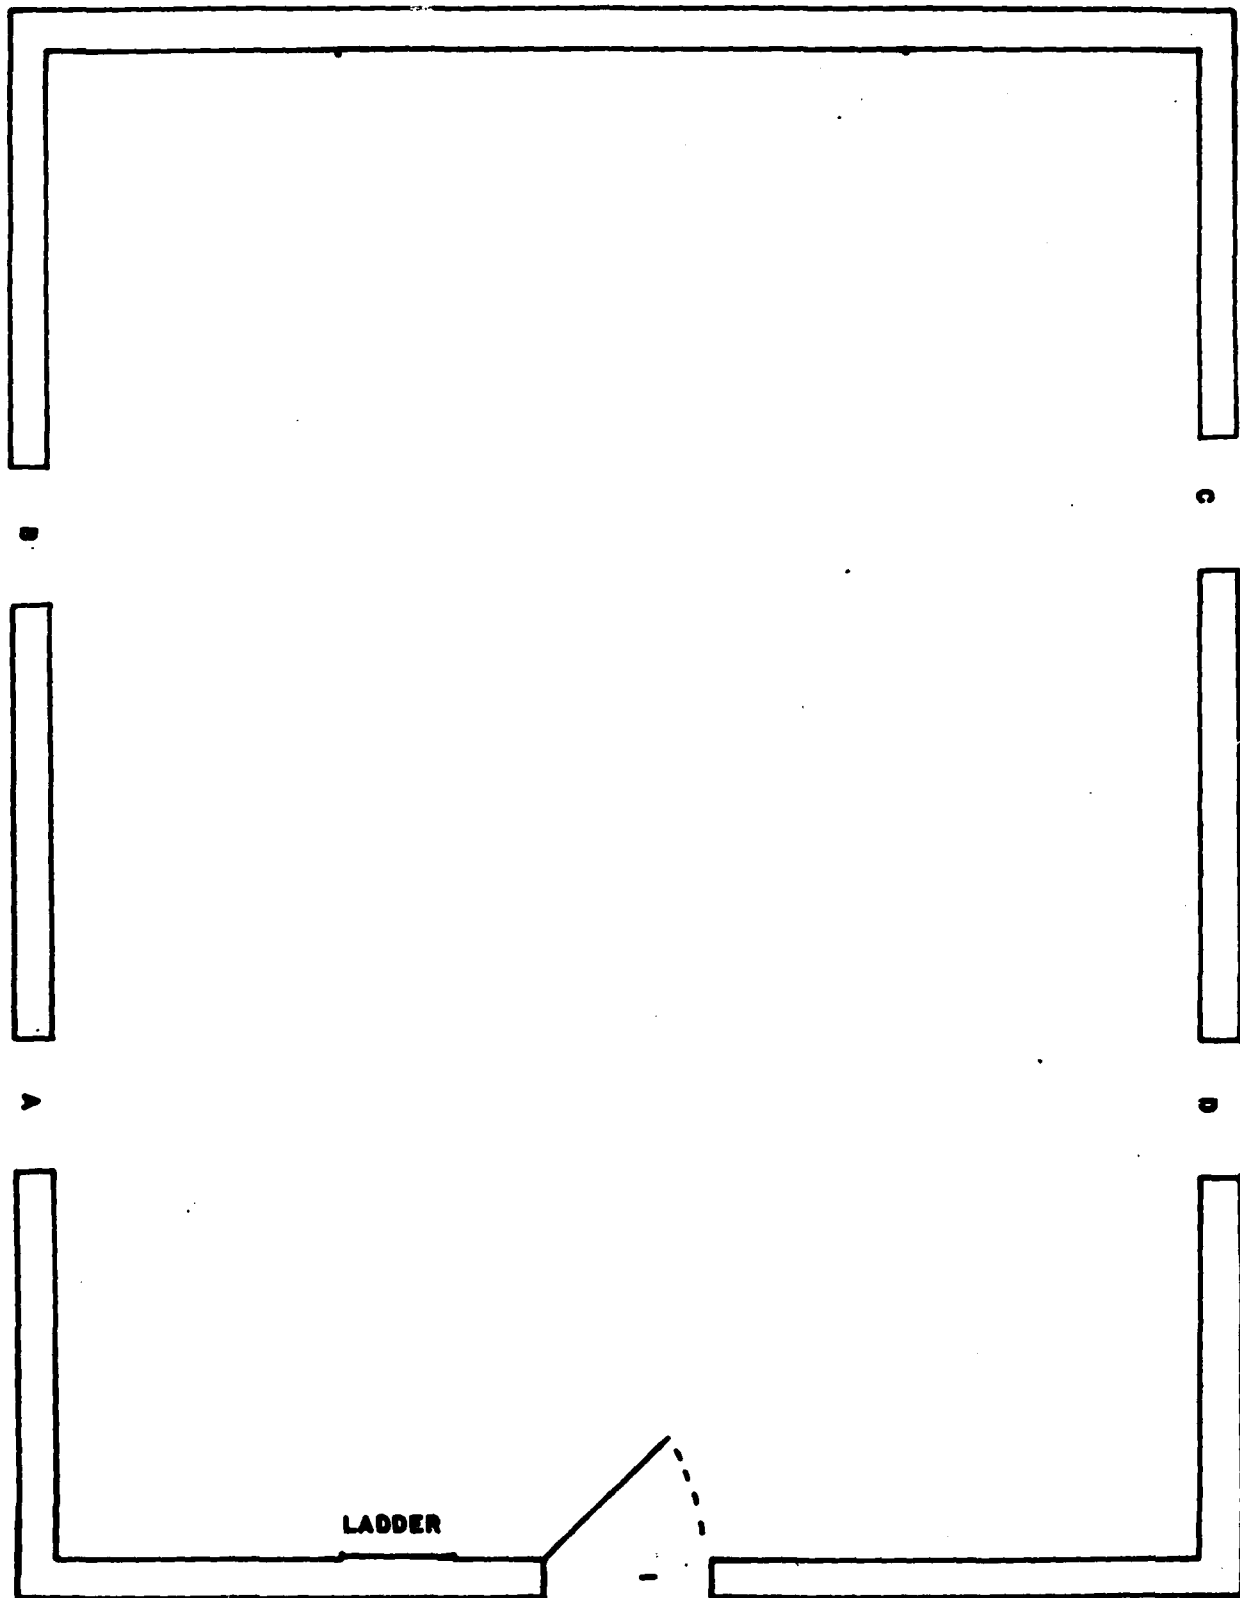
Figure 52. Floor plan of the McKenzie Branch school as reconstructed adjacent to Johnson Central High School, Paintsville, Kentucky.

The McKenzie Branch school has been reconstructed adjacent to Johnson Central High School just northwest of Paintsville and on the northeast side of U.S. Route 23. It is a rectangular 1 1/2 story log structure that contains only a single classroom. Current overall exterior dimensions of the structure are 21'9 1/2" x 28'4 3/4" as measured along the southwest and northwest walls (Figure 52).

The only entrance to the school is through a single five board three batten door located in the middle of the southwest elevation (Figures 52, 53). This door is 6'5" in height and 2'11" in width. It is composed of circular sawed lumber joined with wire nails. It does not seem to be original to the structure as it has sharp, fresh corners and a generally unworn appearance. It may have been made for the school at the time the building was moved to its present location. There is a 7" step-up to the threshold of the door.

There are two windows in the northwest and two additional windows in the southeast walls of the school (see Figures 52, 55). All four windows are of two over two light double hung sash construction. Each of the lights measures 1' in width and 2' in height. The nailed frames are 1 3/4" wide; mullions are 1" in width. The window surround material in all four cases is ca. 5" wide milled lumber. The windows do differ slightly in their height above the school floor. The bottoms of Windows A and B (see Figure 52) are 1'11" and 1'10" above the floor, respectively, while Windows C and D are 1'8" and 1'8 3/4", respectively. Other details of the McKenzie Branch school windows are presented in Table 5.

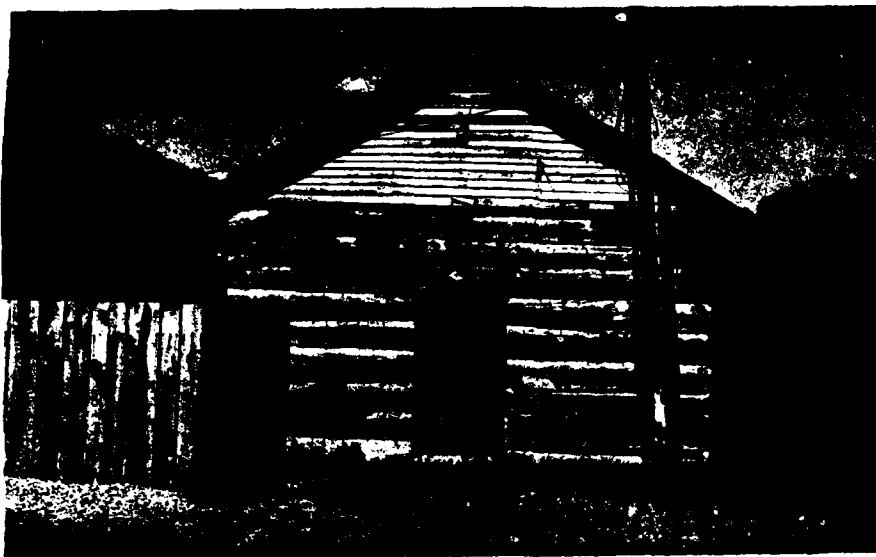
Figure 53. Present southwest elevation of the McKenzie Branch school showing the only entrance to the structure. Note the half dovetail notching of the logs.

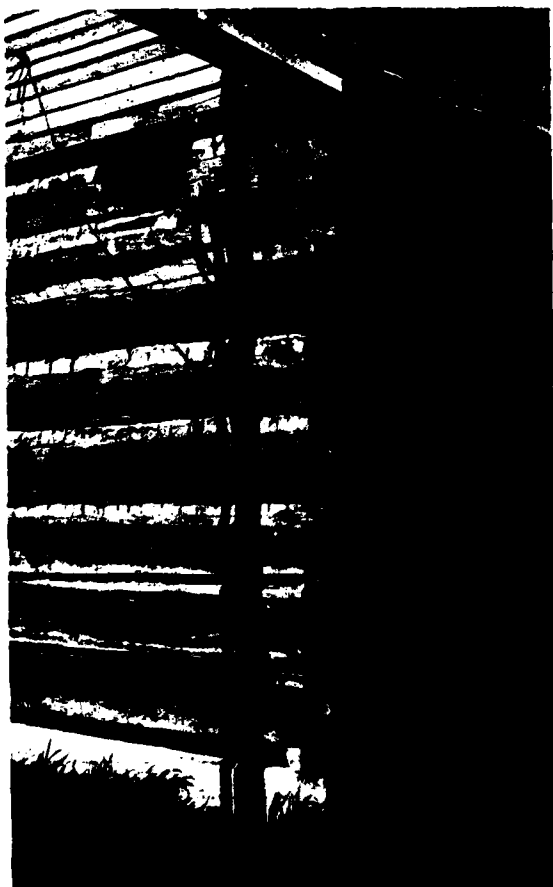
Figure 54. Detail of half dovetail log notching at the south corner of the reconstructed McKenzie Branch school. Note the poured concrete sill used in the reconstruction.

Preparation of the logs in the school is varied; the workmanship is generally good, although serviceable would be a better description. Half dovetail notching is employed throughout except in the case of some logs that are unnotched (see Figure 57) and in the case of the V notched sleeper. In certain cases, the logs have been squared on all four sides (e.g., four logs in the southwest elevation) while others retain bark on the inferior face (e.g., five logs in the southwest elevation) but are decorticated and worked on the remaining surfaces. As measured in the west corner of the building, the worked ends of the logs range in width from 5 3/4"-6" in width. Minimum height of the worked faces averages ca. 6 1/2", while maximum height ranges generally between 7 1/2" and 8". The ends of all logs have been sawed flush with the walls of the school (see Figure 54). Many of the logs retain scoring marks, although this is more noticeable on some of them than on others. (See the log just below the plate on the southwest side of the building, Figure 54.)

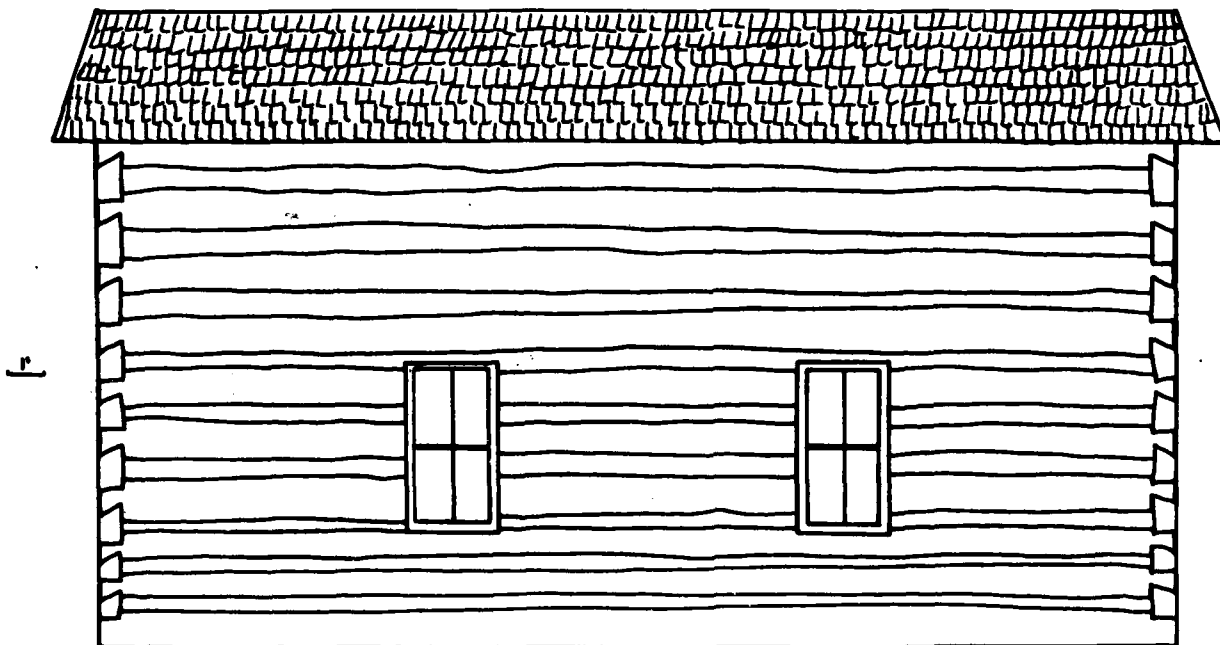
Figure 56. Line drawing of the present northwest elevation of the McKenzie Branch school.

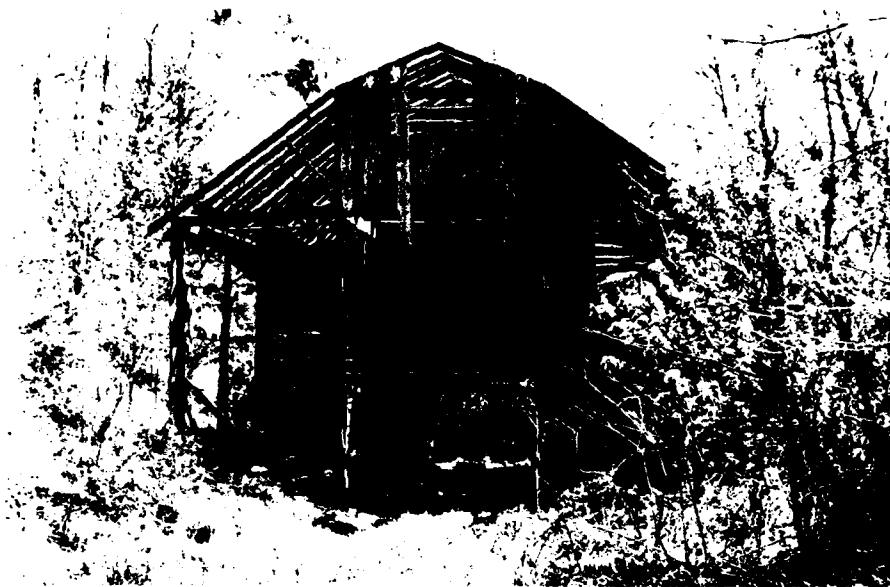
Figure 61. Northeast elevation of the Mitchell Rowland barn. Note the combination of frame and log construction. When the barn was in use, this "skeleton" was encased with boards. Lower Peter Cave Branch is just to the right of the barn.

Attached to the northeast side of the log portion of the barn is a frame construction addition each half of which measures ca. 8'3"-8'6" x 16'3"-16'4" (Figures 60, 61). At the time the government acquired the property in 1974, the barn was covered with vertically applied planking. This gave the barn the overall appearance of a completely frame structure, and it was noted as such in the U.S. Army Corps of Engineers' appraisal. When the initial portion of this survey was conducted in 1978, the frame siding had been stripped from most of the barn, and its actual construction was patently clear.

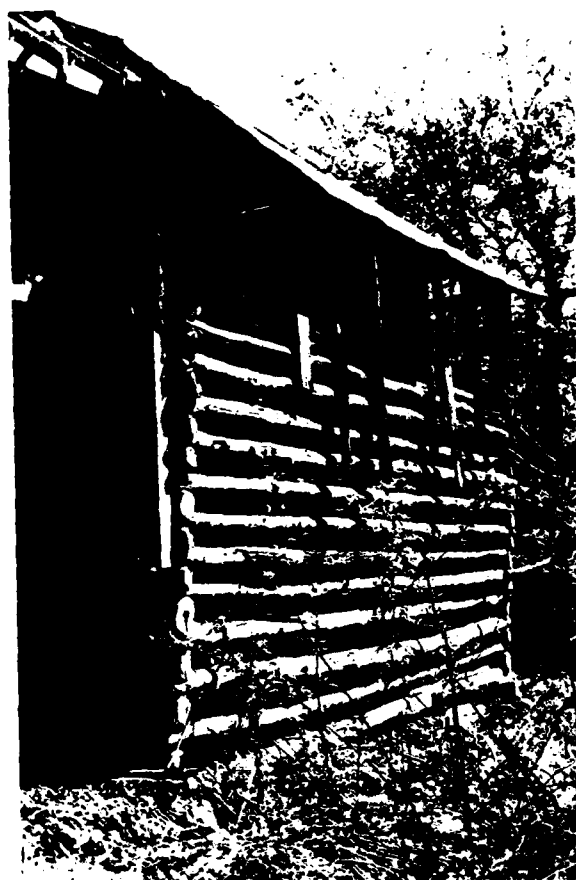
Figure 63. Northwest facade of the log portion of the Mitchell Rowland barn. Note the saddle notching and the (generally) decorticated logs that are of small diameter.

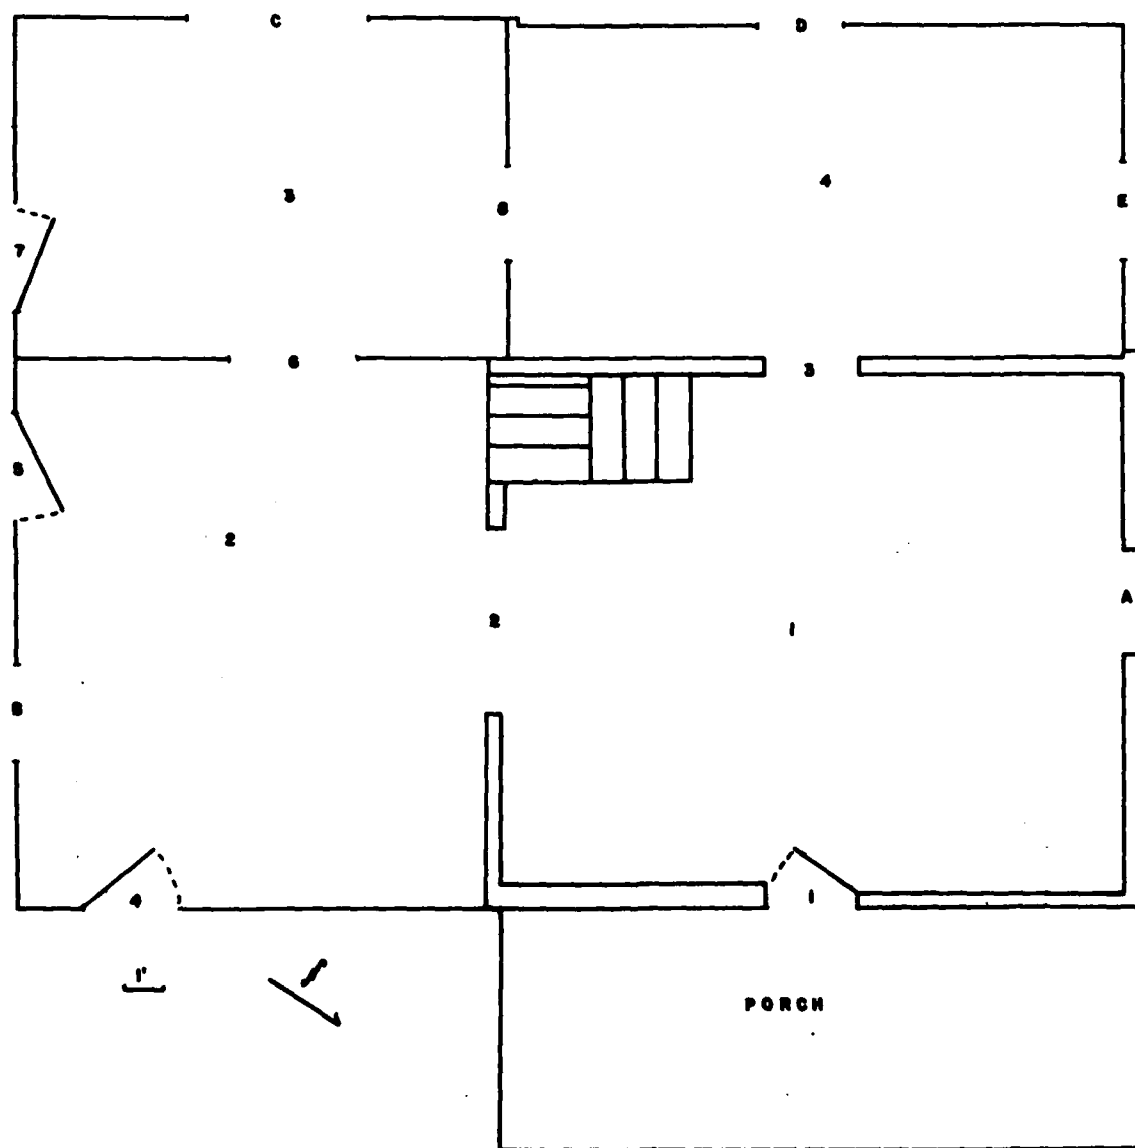
Figure 76. Lower story floor plan of the J. C. Jenkins combination frame and log construction dwelling on Tract 704.

The porch of the Tract 704 dwelling measures 6' x 15'3". The porch floor is 6' above ground surface, and the porch floor to porch roof height is 7'4". At the time of the survey, no steps from the ground surface to the porch existed, and entrance to the dwelling was through Doors 4, 5 or 7 (Figure 76) in the frame addition. The present porch does not appear to be original to the log portion of the home. Its construction was probably necessitated by the elevation of the Door 1 threshold when the structure was moved back from Little Paint Creek and up the hillside to its present location (Figure 78). Whether or not the structure in its original location also had a front porch has not been determined.

The Tract 704 dwelling consists of a total of five rooms including the loft above Room 1. Room 1 (Figure 76) is the principal room in the log portion of the dwelling and appears to have been used as the "living room" area. As noted above, the absence of steps from the ground surface to the porch precluded direct access to Room 1 through Door 1 at the time of the survey. Interior room measurements are 13'3 1/4" x 14'8 1/2", and floor to ceiling height is 6' in the center of the room.

Entrance to the loft is gained by a set of stairs in the southern corner of the room (Figure 76). The loft itself was used for sleeping quarters at least at the time that the Jenkins family occupied the structure (Mary Lemaster Jenkins 1980, pers. comm.).

Room 3 is the kitchen. It is located in the frame addition to the southeast side of the log portion of the dwelling. It can be entered directly from outdoors via Door 7 and from both Rooms 2 and 4 (see Figure 76). There is a step-up between Room 3 and Room 4 of 3". Interior dimensions of Room 3 are 8' x 12'5 3/4". Floor to ceiling height in the center of the room is 6'11". Room 3 has a single window opening (Window C) in the southwest elevation.

There are four exterior doors and four interior doorways in the Tract 704 dwelling. One door is of board and batten construction, while the remainder are of panel construction. The placement of these features is indicated in Figure 76, and general observations and measurements on them are presented below in Table 9.

As noted previously, entrance to the loft (Room 5) in the log portion of the structure is by stairs located in the south corner of Room 1 (see Figure 76). Three steps rise from the floor of Room 1. These join a second set of three steps and a riser arranged at a right angle to the first set. Tread length is 2'8 1/2" while tread width is 10" and tread height is 9". All steps are of circular sawed plank construction and are joined with wire nails.

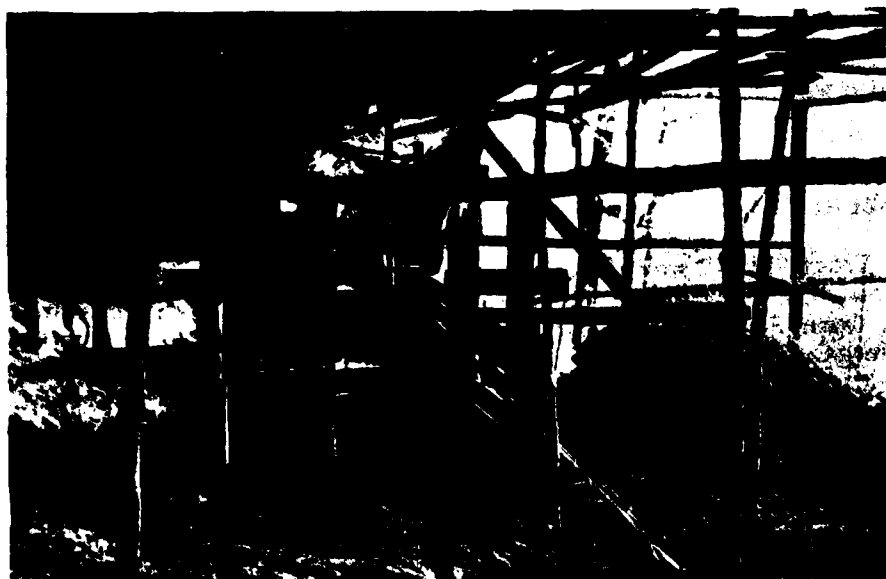
Figure 100. Close-up of the enclosed Activity Unit in the Charles Cochran cliff barn looking northeast.

It is clear from examining Figures 97-100 that the Cochran cliff barn includes a crude, hastily constructed three-dimensional arrangement of ca. 4"-6" diameter poles and milled lumber. In keeping with its construction date in the 1950s, all nails throughout the structure are of the wire type. All materials used in the barn were selected seemingly on the strict basis of availability or ready adaptability. Neither the vertically implanted posts nor the rails that form the tobacco curing racks were modified beyond the minimum necessary to erect the latticework that fills the interior of most of the rockshelter. The dimensions of this network of interconnected poles and rails are governed by the shape or configuration of the floor, walls and roof of the rockshelter. Within these bounds, the structure makes thorough use of the available space beneath the massive overhang.

At its maximum height, the roof stands ca. 25' above the shelter floor. Within this space stand two and often three tiers of posts and rails (Figures 97-100). Throughout the barn, 29 vertically implanted poles and seven vertically implanted boards (1" x 5", 2" x 4", 2" x 6") are used. Separation between each pair of the poles varies greatly from a minimum of ca. 6 $\frac{1}{4}$ " to a maximum of ca. 13 $\frac{1}{4}$ ". As suggested above and as can be seen in Figure 96, horizontal separation between the vertically implanted posts is haphazard. Post locations were dictated it seems by necessity and by the morphology of the rockshelter floor, walls and roof more than by human design or plan.

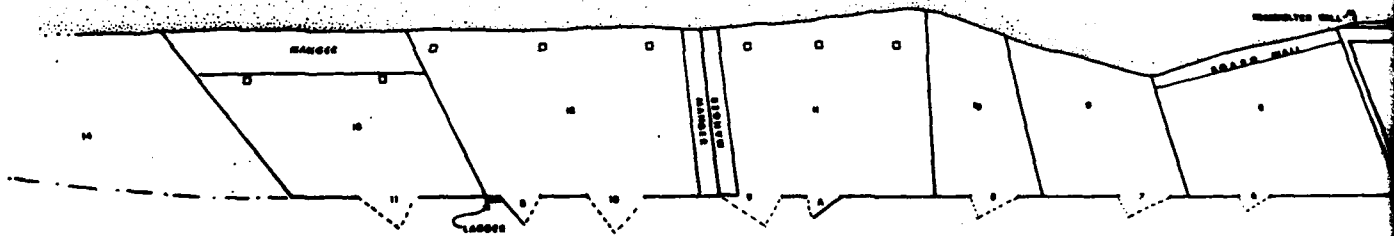
Figure 109. Floor plan of the Jim Gilliam cliff barn on Tract 924.

The open-air Activity Units (Activity Units 1 and 14) are located on either end of this lengthy but narrow building. The morphology of the barn is governed entirely by the massive sandstone overhang that forms a natural but shallow roof over the barn. In several cases, the sandstone floor and wall of the shelter also form the floor and wall of the corresponding barn Activity Unit. A board or plank wall comprises the back (north) wall of other Activity Units (6, 7, 8). Some units (5, 7, 8) have raised wooden floors, and two of these (7, 8) may have been used for storing grain or other perishables that require a dry floor.

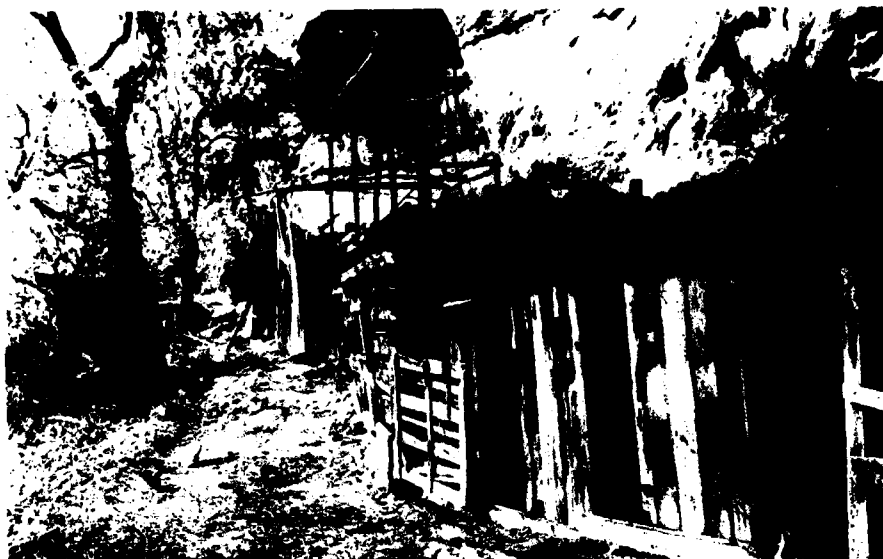
Figure 112. The Jim Gilliam cliff barn looking east to west across the southern elevation. The mixed frame and log construction of the barn is readily apparent in this photograph. The half dovetail notched logs used in Activity Unit 7 are thought to be from another structure and reused in the barn.

Activity Unit 7 is the only unit in the cliff barn entirely constructed of logs. There are seven logs in the east and west elevations and eight logs in both the north and south elevations. The height of the log walls above ground surface is 7'9". The U.S. Forest Service Center for Wood Anatomy Research identified the log wood as yellow pine (*Pinus* sp.). The interior and exterior surfaces of each log have been prepared with a broadax while the superior and inferior surfaces retain their natural convexity. In most cases, however, the superior and inferior surfaces are decorticated. Larger logs tend to have been used in the lower courses of the building. The logs range in height from 9" to 1' and are ca. 5" wide. No mud chinking is evident in this crib. It has been mentioned above that corner notching on the logs in this Activity Unit is exclusively of the half dovetail variety. The notching is of highly variable quality, and the ends of the logs are poorly worked (see Figure 114). On average, the log ends attain a maximum height of ca. 7" and a width of ca. 4"-5". In several places, shims have been inserted between intersecting logs to correct for poor alignment. It seems quite certain from the reworked corner notches that the logs were used in a previous structure and have been refitted and reused in this cliff barn. Measured across the southern elevation, Activity Unit 7 is 14'3" in length. Front to back depth of the unit is 8'8". Total usable floor space in the unit is 123.5 ft<sup>2</sup>. There is a single four board three batten door to the unit centrally positioned in the southern elevation (see Figure 113). The boards are circular sawed and vary from 8" to 9" in width. The top and middle battens are separated by a distance of 1'7", while the middle and bottom battens are 2' apart. All of the 4" wide battens are mounted on the exterior of the door which is hung from one strap hinge and one tee hinge. These are mounted on the right (east) side of the door which is secured by a hasp lock and a simple wood turn. A five link forged chain (see Figure 113) serves as a door pull. The south facade of the Activity Unit is elevated on two undressed sandstone piers (see Figure 116). This has created a high step-up into the unit of 2'2". The interior of this unit differs from most of those previously described as it has both a board floor and ceiling. The flooring consists of 8" wide circular sawed lumber laid east to west. The flat roof is formed from 3"-4" wide circular sawed lumber also laid in an east to west direction. Above the Activity Unit is a two tier crude pole construction scaffolding (see Figures 112, 115) probably used for curing tobacco. The function of Activity Unit 7 is unknown, but the use of a hasp lock (unobserved elsewhere in the barn) and the presence of both an elevated floor and a roof suggest storage of a valuable crop, perhaps tobacco. Attached to the southeast corner of Activity Unit 7 is a wooden gate ca. 9' in length and 4' high. It is composed of seven horizontal rails joined by three paired vertical members. The gate is hung from two crude forged hinges nailed to Activity Unit 7. When in use, the gate would have separated the functions of Activity Units 1 through 6 from those of Activity Units 7-14.

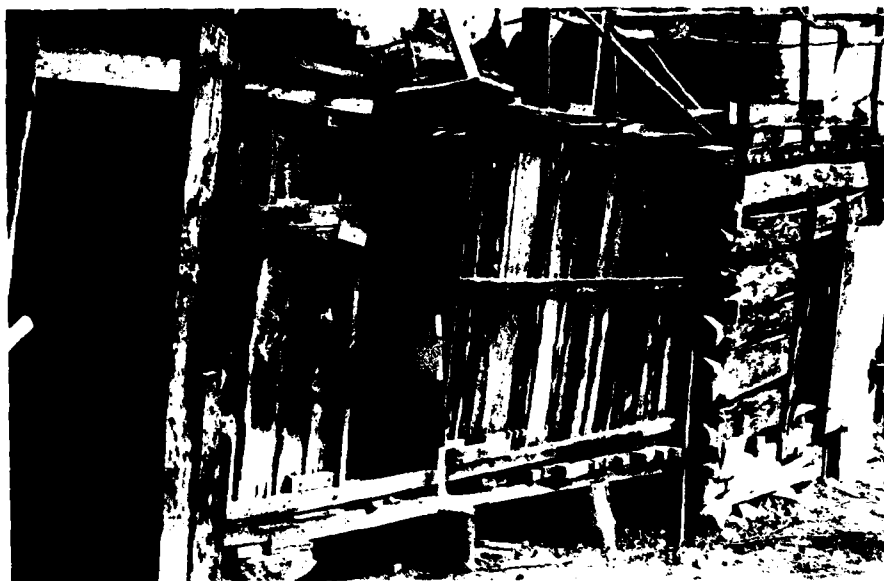
Figure 116. Close-up of frame construction Activity Unit 8 in the Jim Gilliam cliff barn. This unit is fairly typical of the frame construction Activity Units in the barn. Note the horseshoe mounted on the wall to the left of the door opening.
